The Road Inventory of Matagorda Island National Wildlife Refuge Austwell, TX

Prepared By:
Federal Highway Administration
Central Federal Lands Highway Division
December 2009

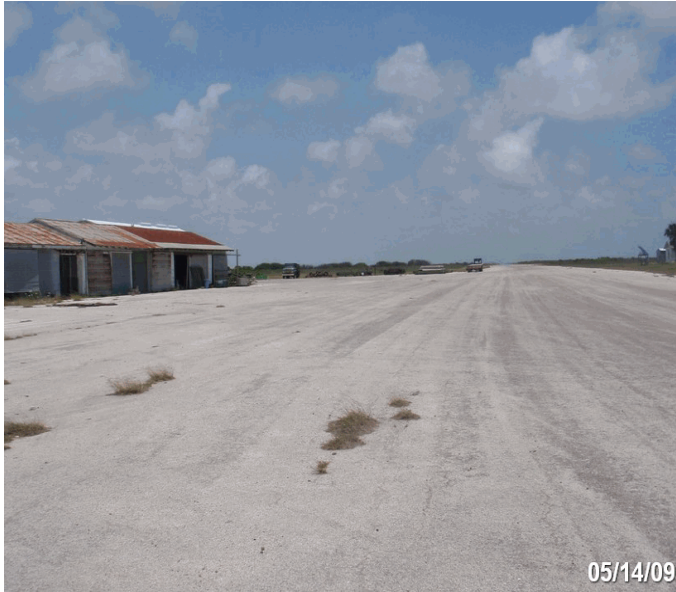
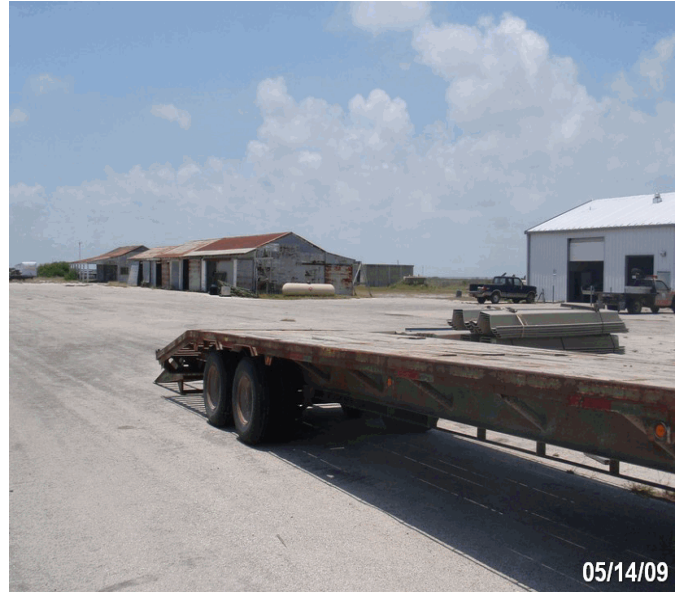
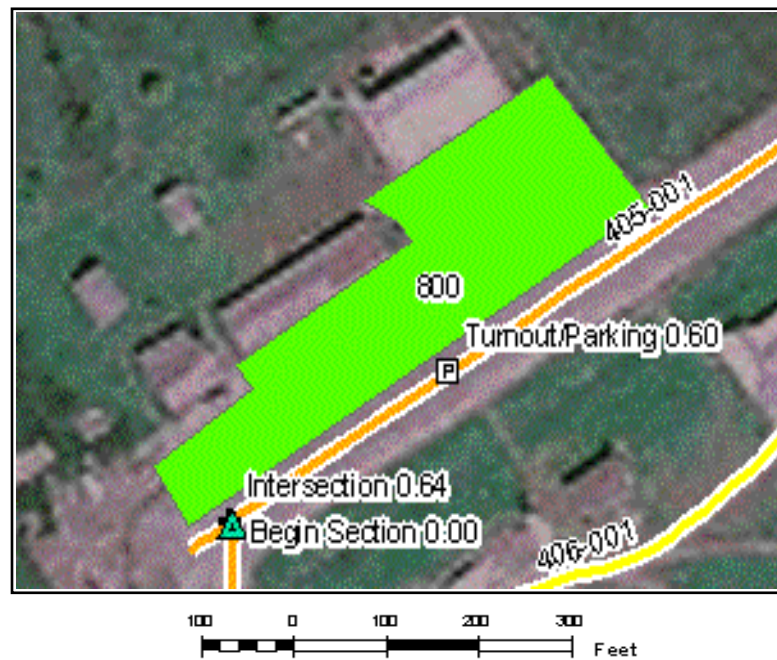
| Asset Number | Date Visited | Surface Type | Area (Sq Ft) | Condition | Cost to Improve |
|---|---|---|---|---|---|
| | 05/14/2009 | Concrete | 44,867 | Good | 5,500 |

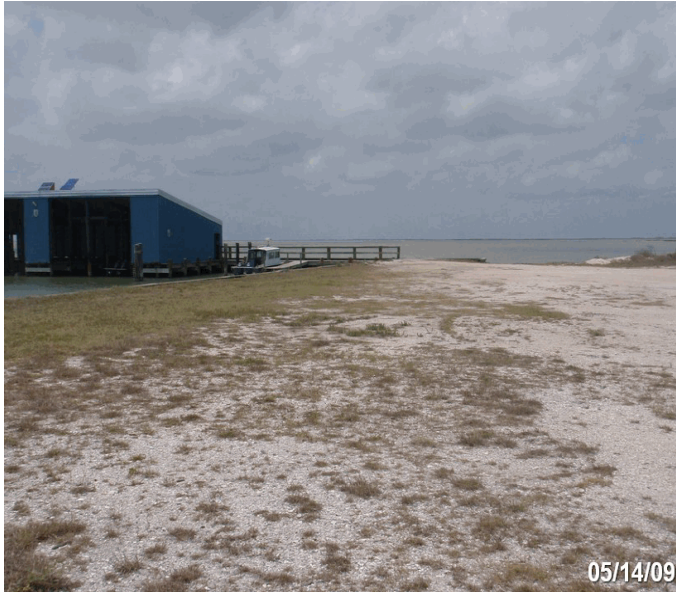
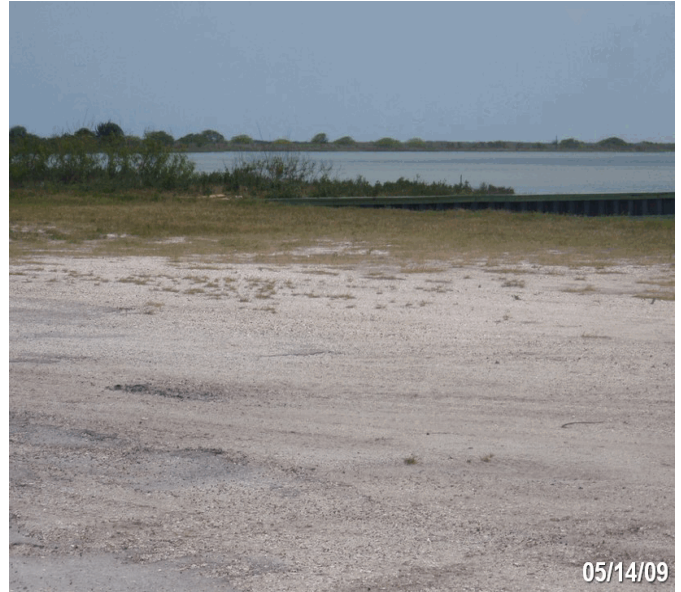
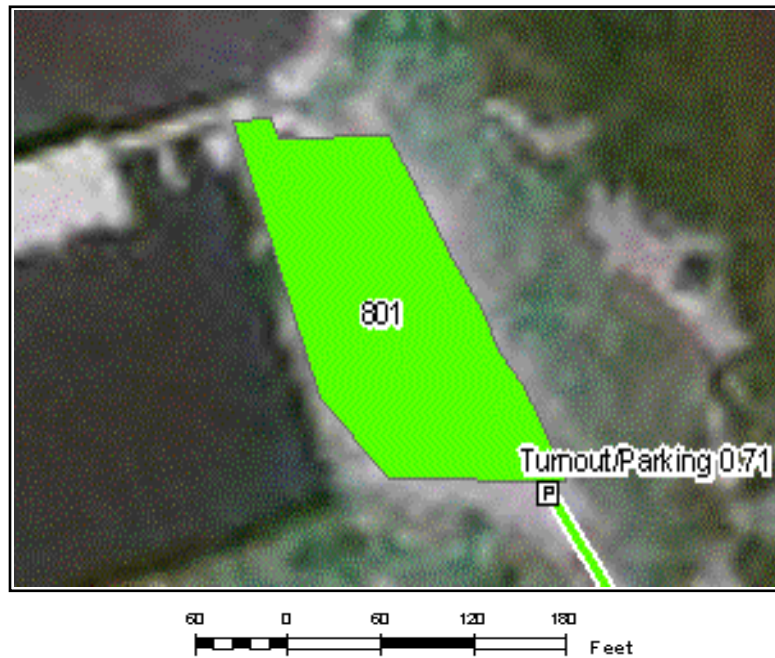
801: Boathouse Parking

| Asset Number | Date Visited | Surface Type | Area (Sq Ft) | Condition | Cost to Improve |
|---|---|---|---|---|---|
| | 05/14/2009 | Gravel | 14,923 | Good | 2,000 |

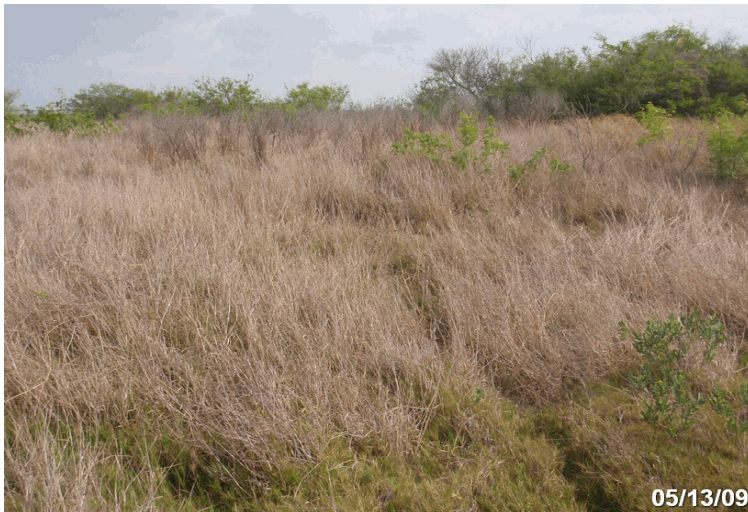
Photo # MATA_C4_0194 - MP 3.66 - Problem Area 004
